HURRICANE IMPACT
ON GULF COAST BARRIERS

Final Report No. 2 to the
Office of Naval Research

Geologic Response to Hurricane Impact on Low-Profile Gulf Coast
Barriers.

Hurricane Impact at Dauphin Island, Alabama.

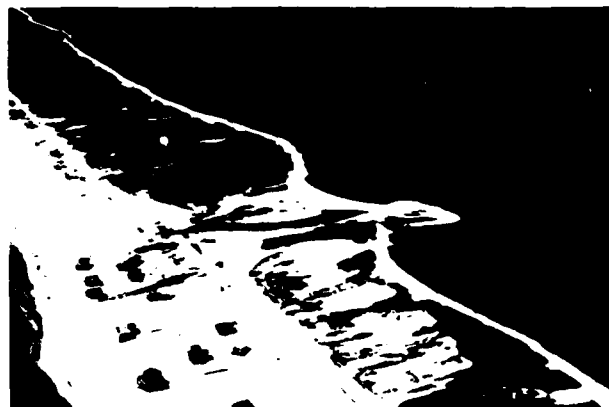
Figure 18. Modification of the flame-shaped washover fans six months after the passage of *Frederic*. Note the landward migration swash bars along the fan crest. (See fig. 13 (Point B) relocation of this oblique aerial photo). Photo taken March 12, 1980

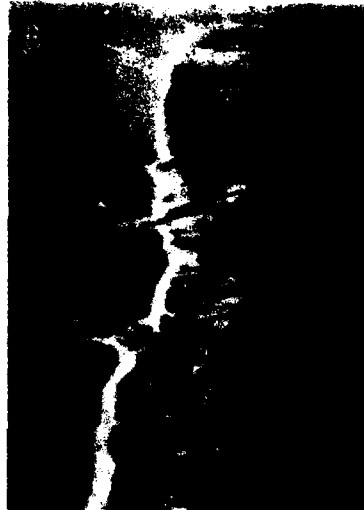
Figure 16(B). An aerial view along Little Dauphin Island towards the southeast. Note the flame-shaped sand bodies associated with each newly breached inlet extending into Mobile Bay. (Photo taken March 12, 1980).

The ebb-surge primarily affected Little Dauphin Island by breaching or reopening three inlets and forming a deep scour trough along the Mobile Bay margin with flame-shaped washover fans extending into the bay (fig. 16).
